**REPORT TO  
HEALTH INFRASTRUCTURE**

**ON  
DETAILED SITE INVESTIGATION**

**FOR  
PROPOSED HOSPITAL REDEVELOPMENT**

**AT  
TEMORA HOSPITAL, 169-189 LOFTUS STREET,  
TEMORA, NSW**

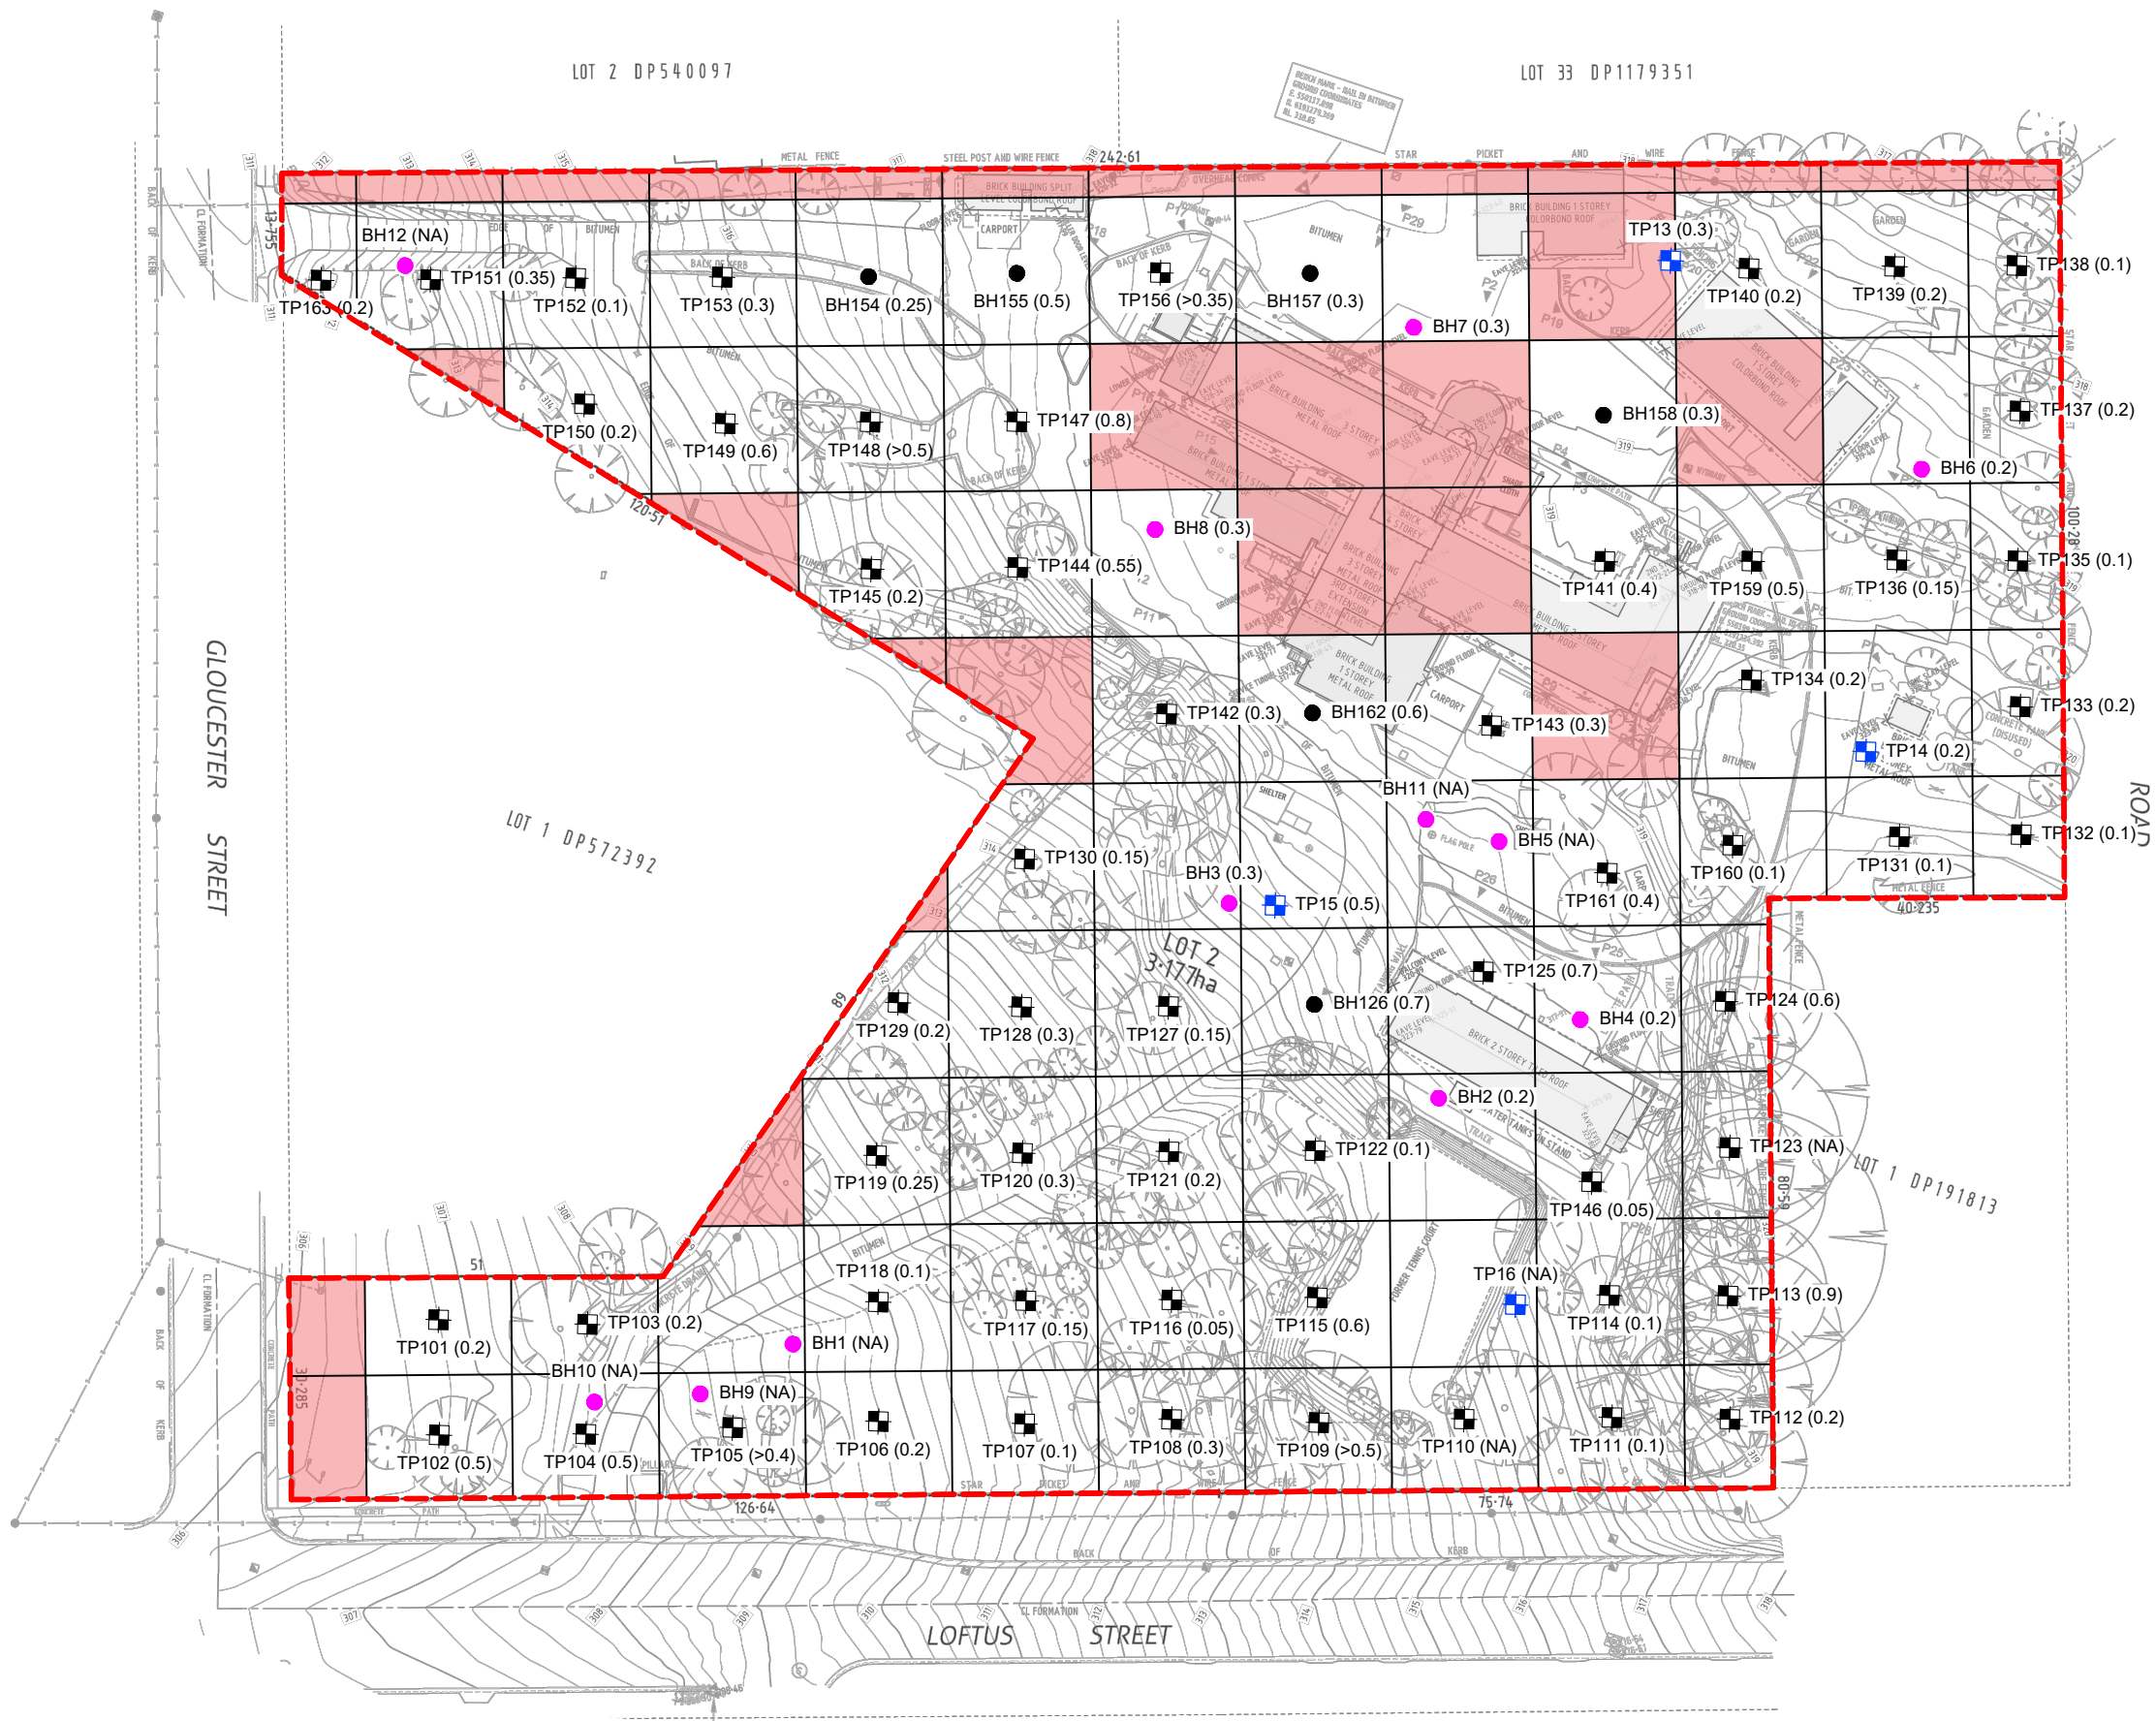
Title: <b>SAMPLE LOCATION PLAN</b>	
Location: 169-189 LOFTUS STREET, TEMORA, NSW	
Project No: E35822PR	Figure No: 2
<b>JKEnvironments</b>

A summary of the subsurface conditions encountered during the investigation is presented in the following table. Reference should be made to the borehole and test pit logs attached in the appendices for further details.

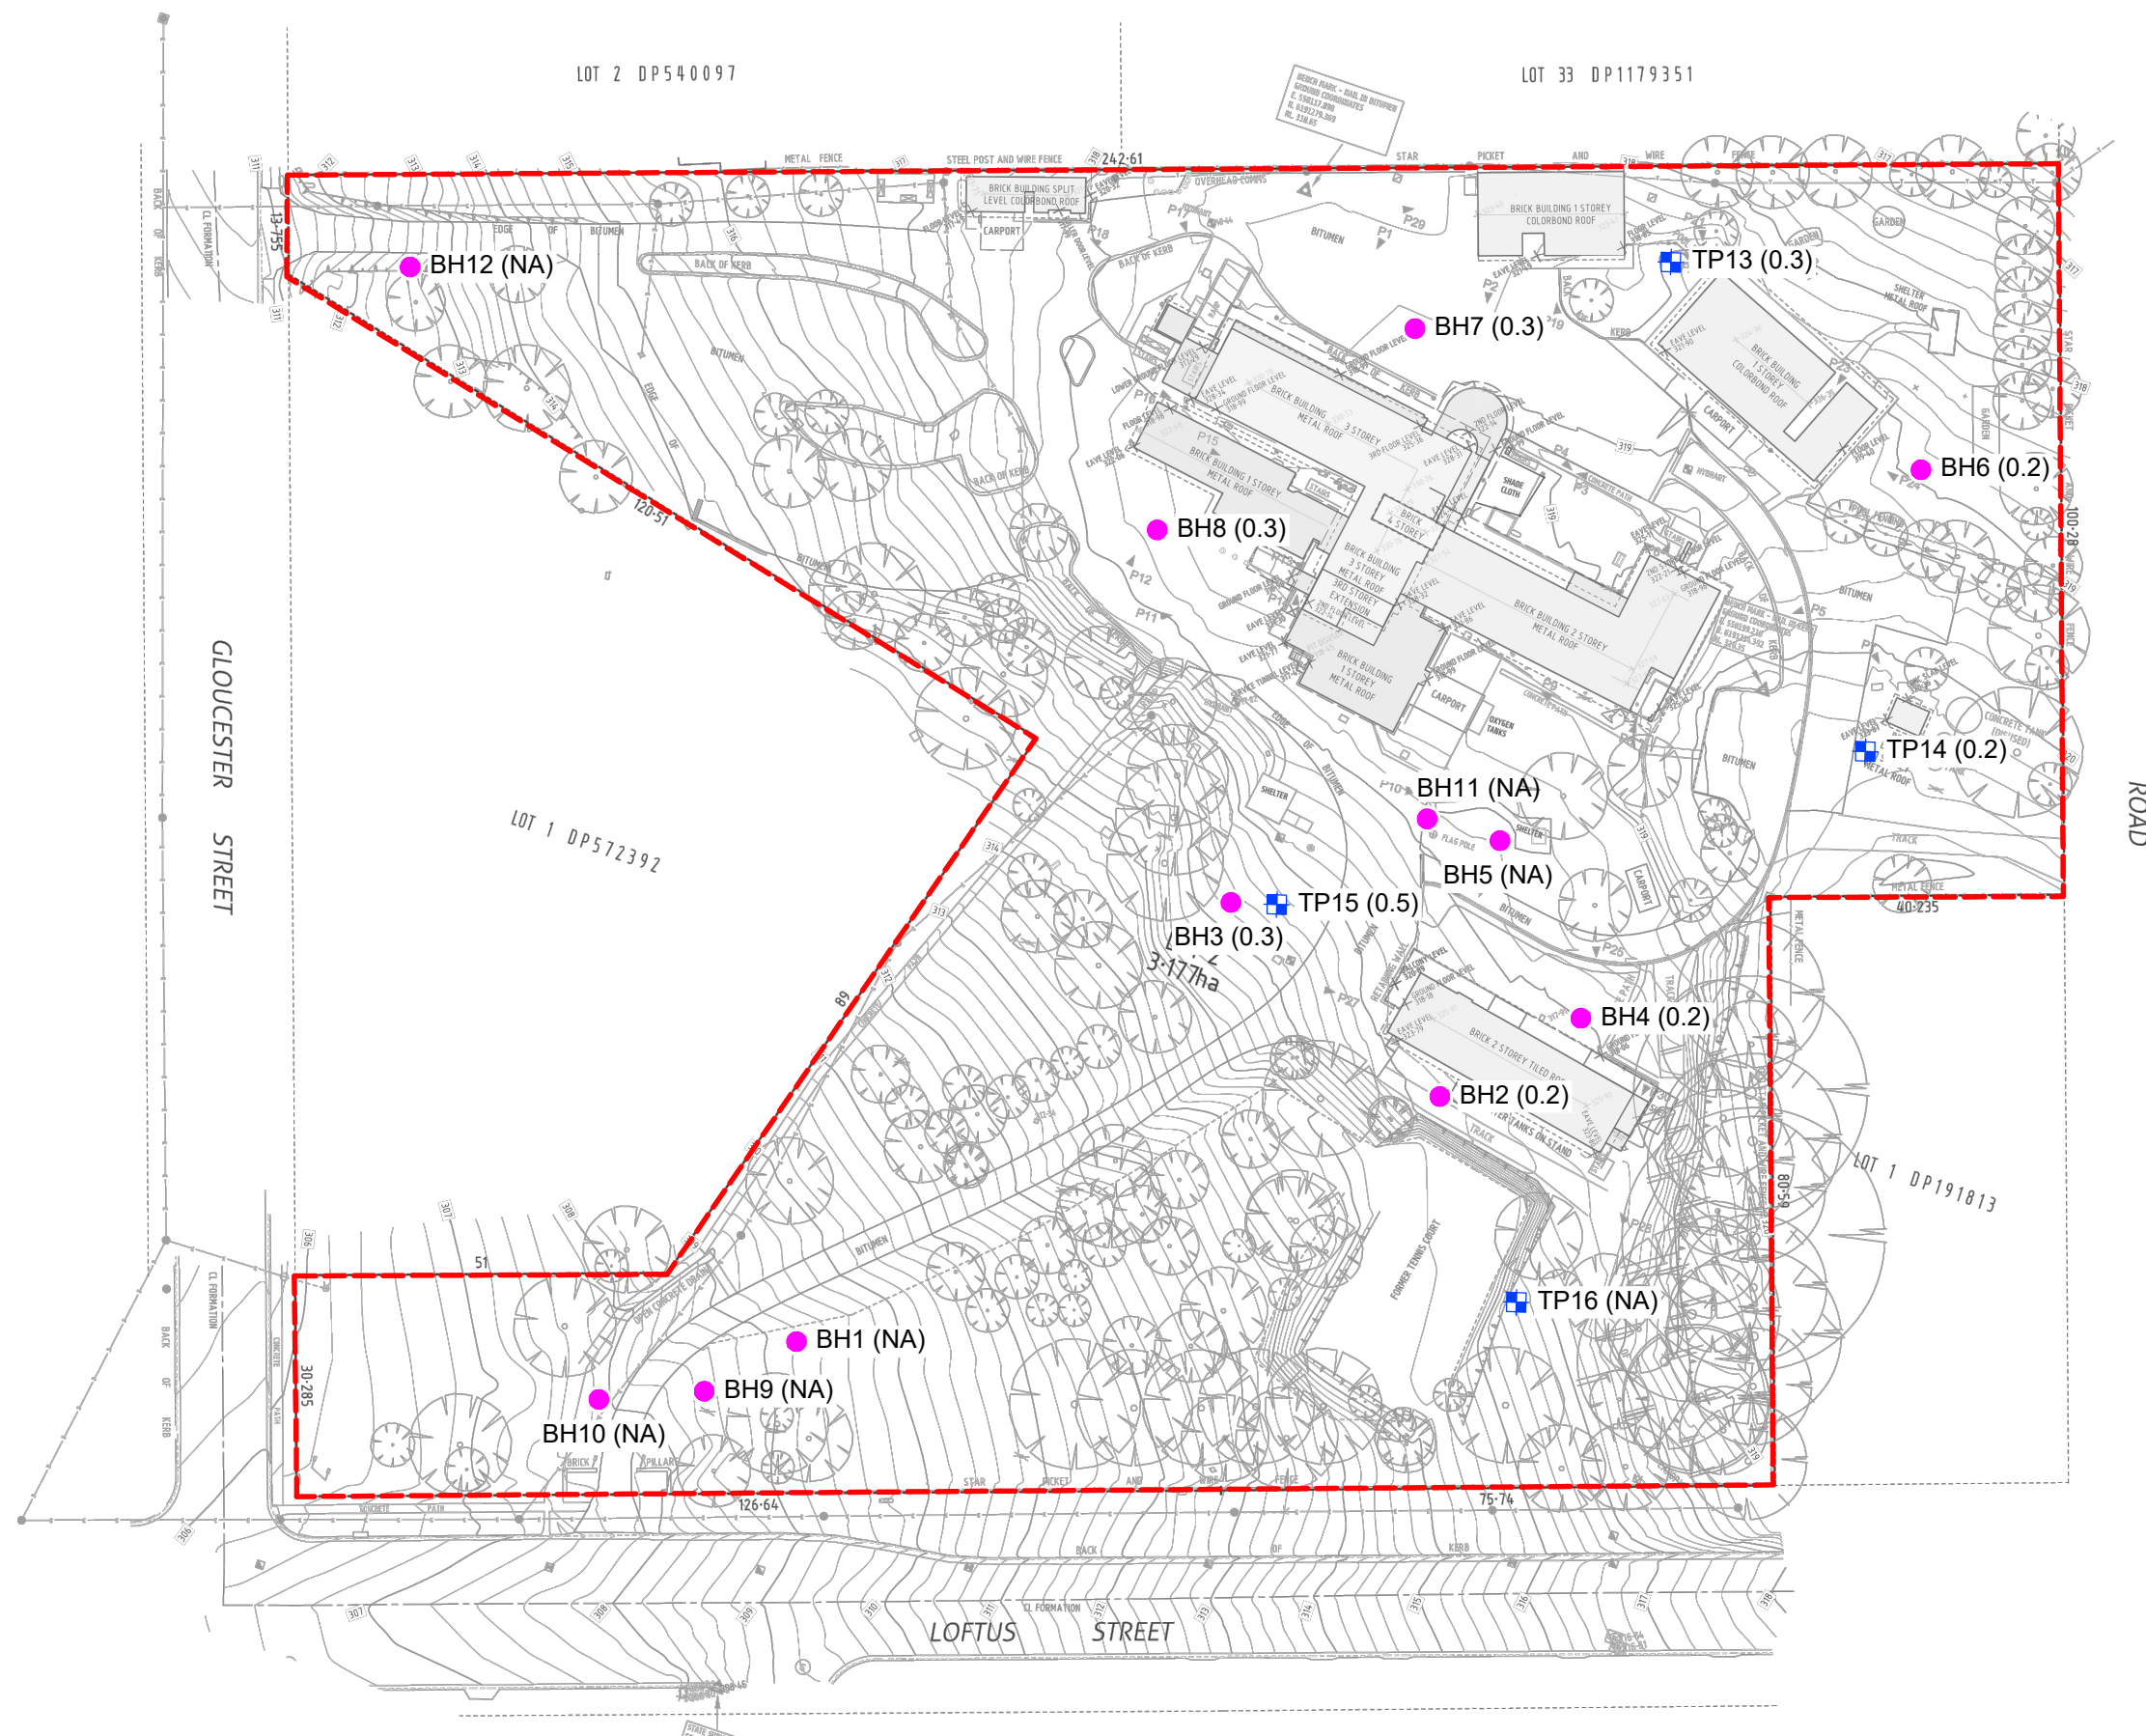
Title: <b>PSI SAMPLE LOCATION PLAN</b>	
Location: 169-189 LOFTUS STREET, TEMORA, NSW	
Project No: E35822PR	Figure No: 3
<b>JKEnvironments</b>

Lead was identified in surficial (0-100mm) fill soil in TP131 at a concentration above the human health SAC. TP131 was located in the east of the site, to the east of the main hospital building and driveway, as shown on Figure 3 attached in the appendices. The source of the lead was considered likely to be associated with impacted fill imported to the site, although there is a potential that the lead could be associated with minor impacts from hazardous building materials (i.e. lead-based paint) given the proximity of TP131 to BH4 where FCF was identified at the ground surface. The results of leachate analysis indicated low potential for the lead

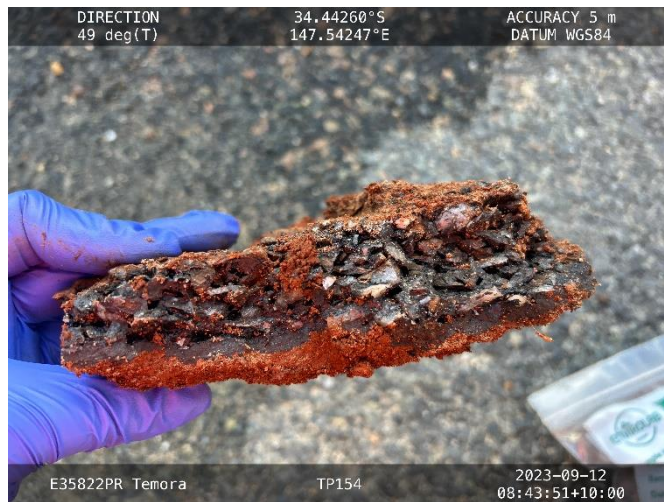
JKE note that the restricted solid waste classification was due to elevated PAH concentrations. Asphalt fragments were generally observed in these areas which may have contributed to the elevated PAH concentrations in the soil samples. Further assessment including additional testing is required to confirm the final waste classification prior to off-site disposal. The anticipated waste quantities should also be confirmed at that time and documented in the report.

Photograph 7: Asphalt fragment in TP154

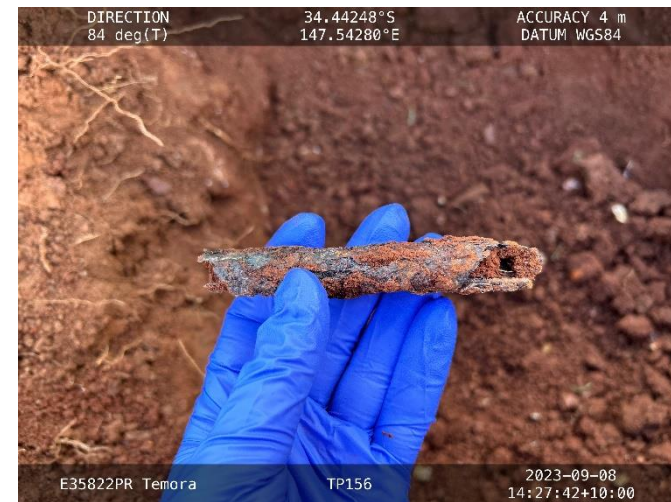
Photograph 8: Metal fragment in TP156

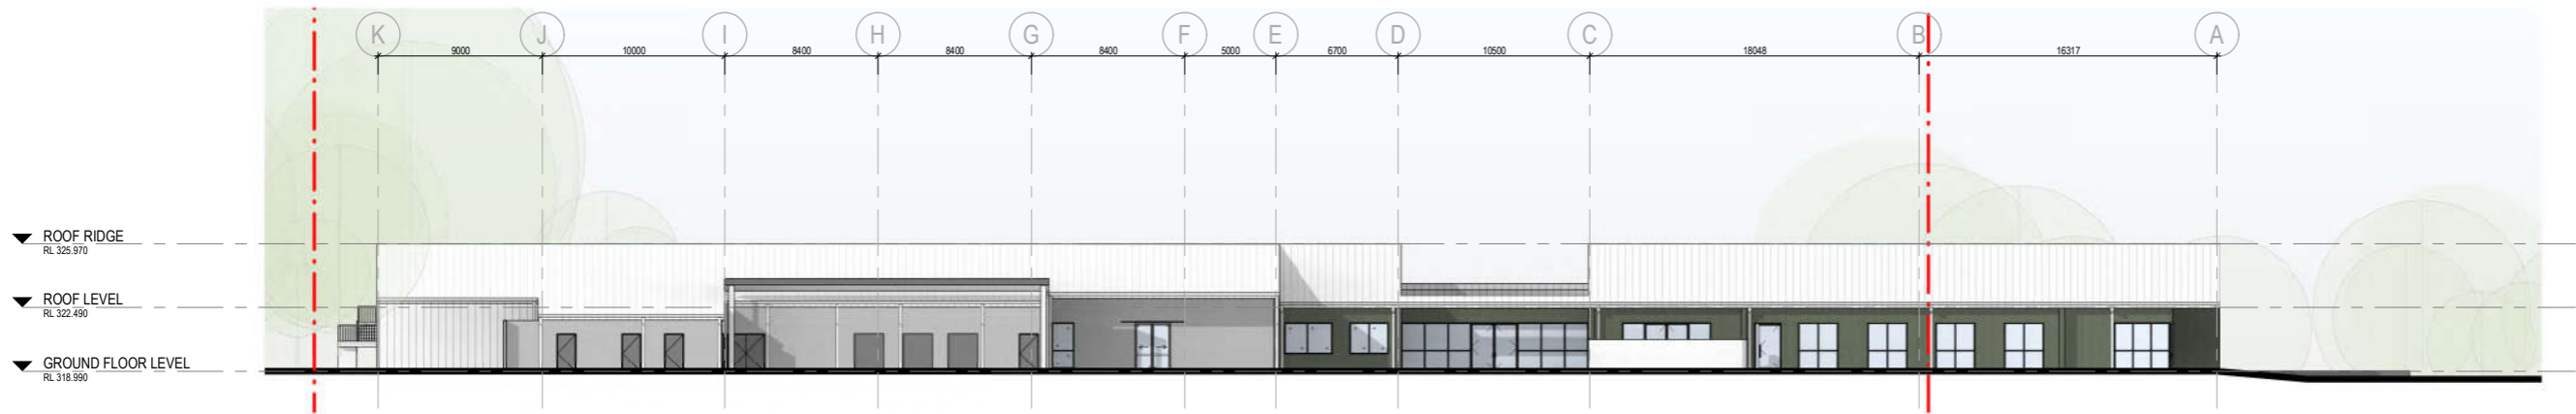
**1 ELEVATION NORTH (SD)**  
1 : 200

- SITE BOUNDARY
- WHITE METAL STANDING SEAM
- GREEN FIBRE CEMENT PANELS
- GLAZING
- GLAZED BRICK / TILE
