**REPORT TO  
HEALTH INFRASTRUCTURE**

**ON  
PRELIMINARY (STAGE 1) SITE INVESTIGATION**

**FOR  
PROPOSED ALTERATIONS AND ADDITIONS**

**AT  
TEMORA HOSPITAL, 169-189 LOFTUS STREET,  
TEMORA, NSW**

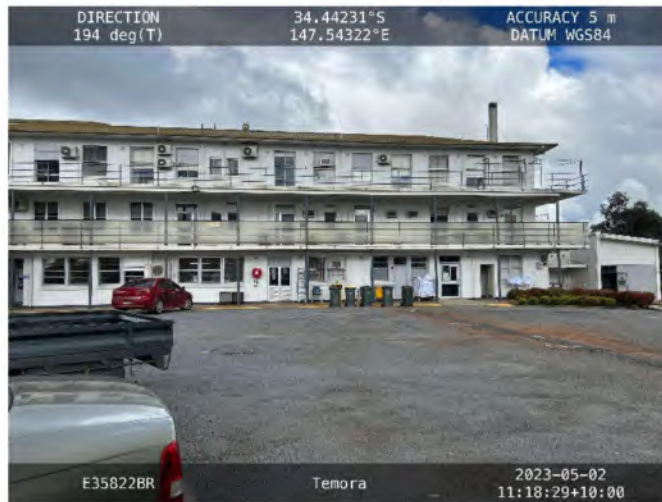
The buildings were mostly located within the northern and central portions of the site and appeared to be generally in good condition based on cursory inspections. The main hospital building was a three-storey building of brick and fibre cement construction, with metal roofing and timber and concrete flooring. A single-storey storage building of brick construction with metal roofing and concrete flooring adjoined to the west of the main hospital building.

Photograph 1: Main hospital building

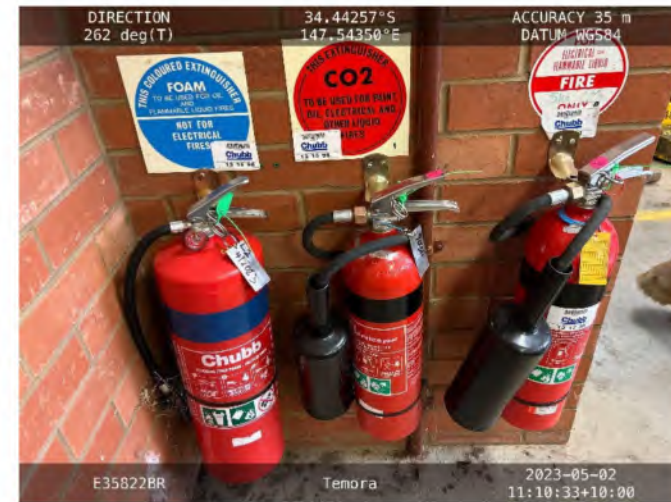
Fire extinguishers were observed in several locations across the site. The fire extinguishers were predominantly carbon dioxide (CO<sub>2</sub>) and dry powder type extinguishers. A foam-type fire extinguisher was observed within the maintenance building. The extinguisher was marked as 'Fluorine-free', indicating it did not contain per-and polyfluoroalkyl substances (PFAS) within the foam matrix. During the inspection, no visible evidence of discharge/use of the fire extinguishers was observed.

Photograph 6: Fire extinguishers in Maintenance building

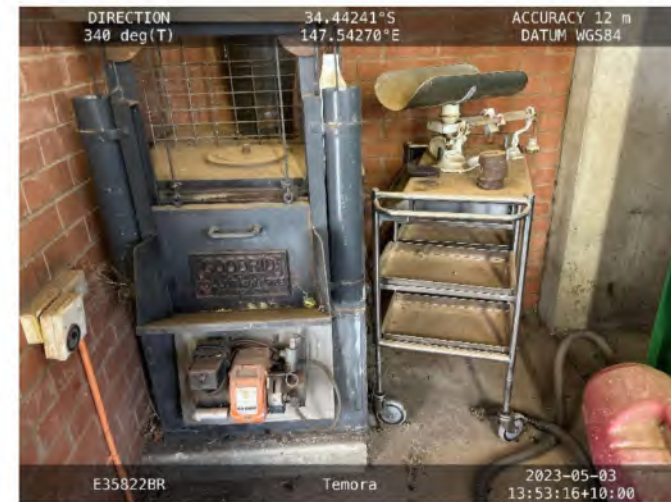
An incinerator was observed within the boiler room located within the north-west of the site.

Photograph 8: Incinerator in Boiler room

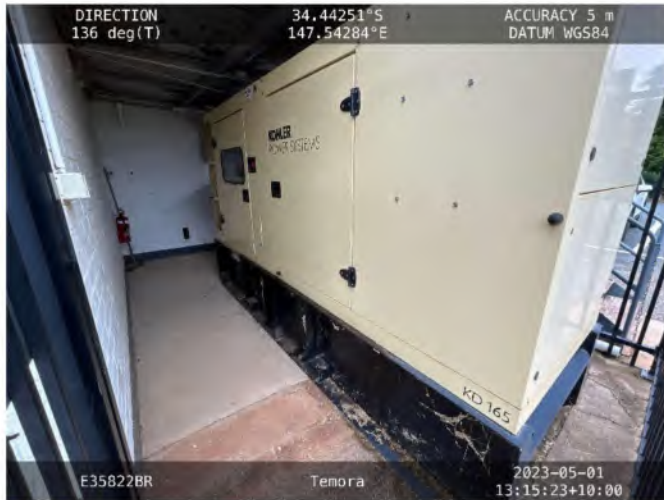
Three substations were observed to the west of the boiler room, and a self-contained back-up generator was located adjacent to the west of the main hospital building.

Photograph 9: Generator

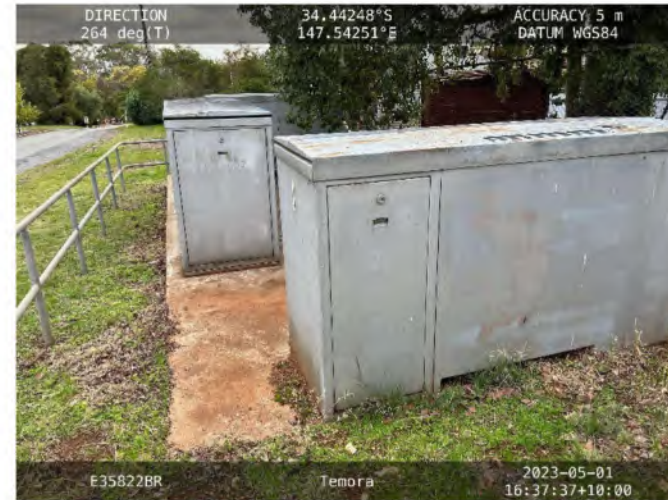
Photograph 10: Electrical substation

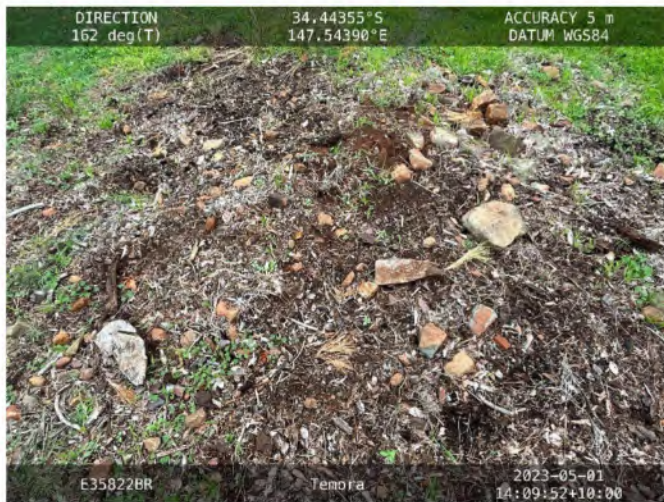
Exposed fill soils were observed in the formed garden areas of the site. A steep batter was observed in the south of the site with a large flat area at the base. The provided survey indicated this was a former tennis court.

Photograph 11: Exposed fill soils at surface

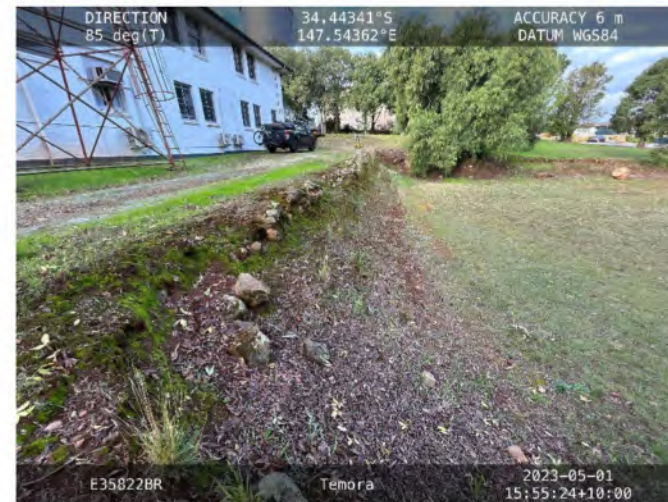
Photograph 12: Evidence of cut/fill
