**REPORT TO  
HEALTH INFRASTRUCTURE**

**ON  
REMEDIATION ACTION PLAN**

**FOR  
HOSPITAL REDEVELOPMENT**

**AT  
TEMORA HOSPITAL, 169-189 LOFTUS STREET,  
TEMORA, NSW**

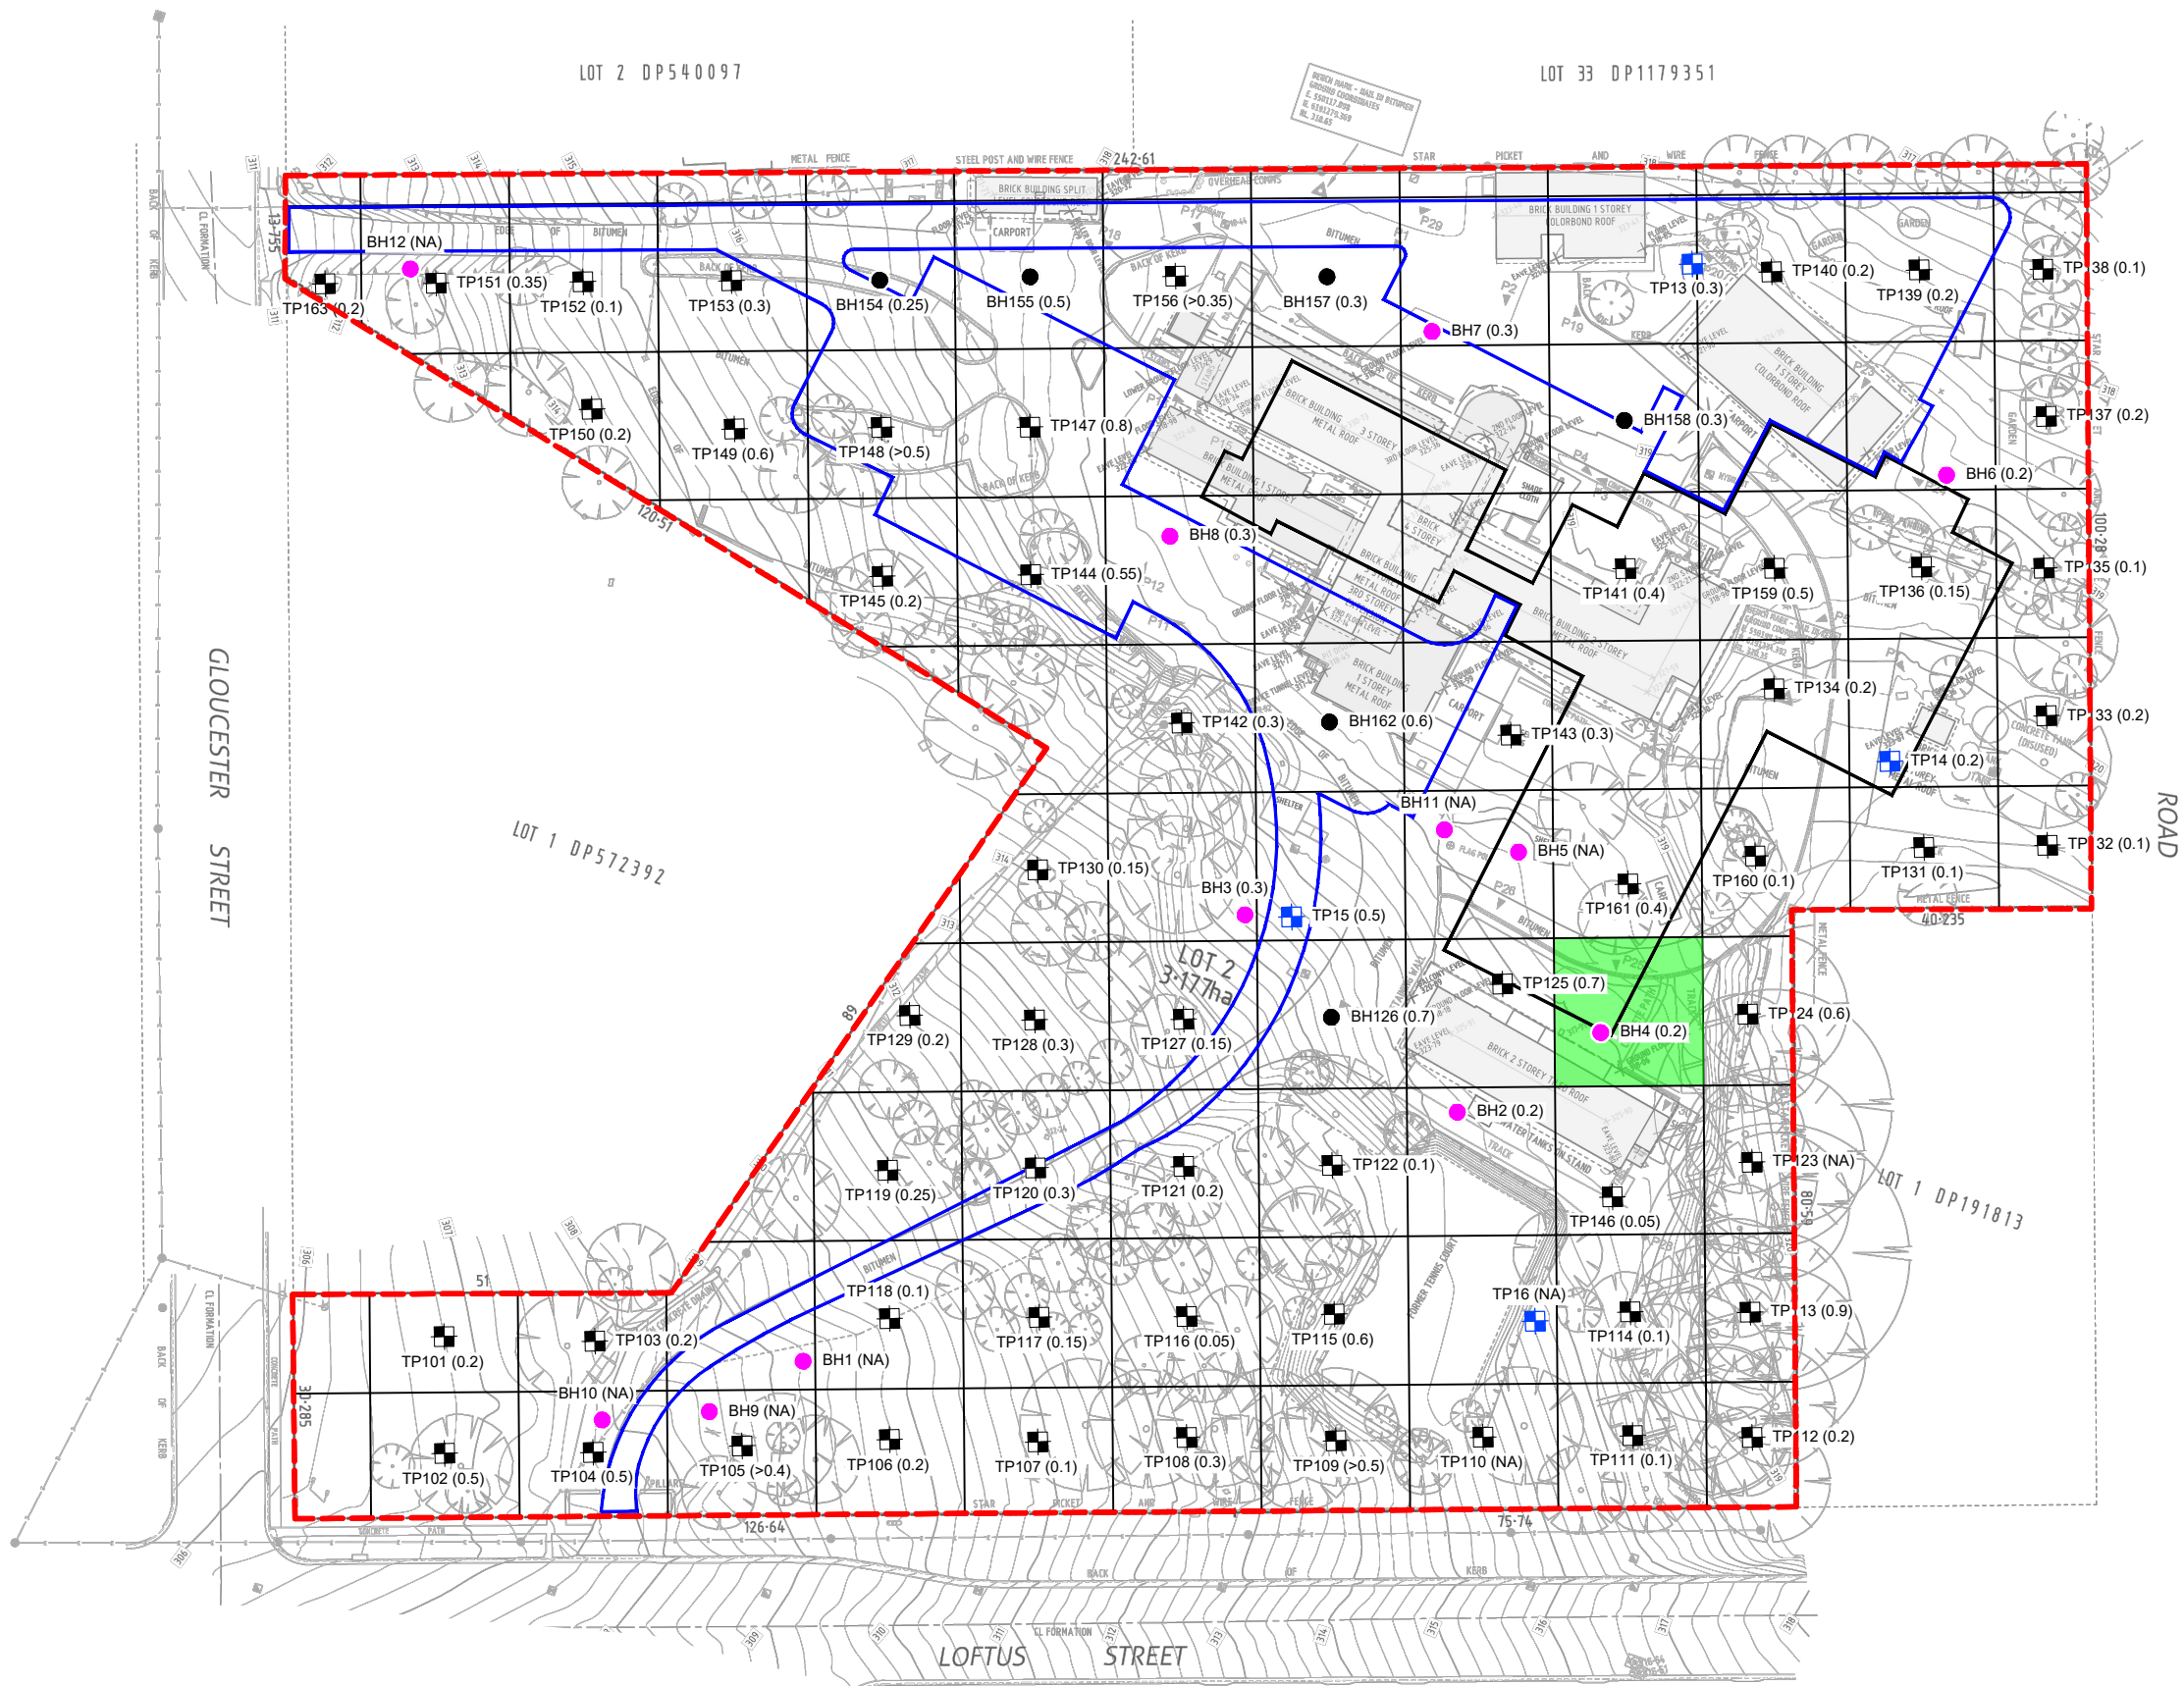
<b>APPROXIMATE REMEDIATION AREAS PLAN</b>	
Location: 169-189 LOFTUS STREET, TEMORA, NSW	
Project No: E35822PR	Figure No: 5
<b>JKEnvironments</b>

- - - APPROXIMATE SITE BOUNDARY
- BH(Fill Depth) BOREHOLE LOCATION, NUMBER AND DEPTH OF FILL (m) (PSI, 2023)
- TP(Fill Depth) TEST PIT LOCATION, NUMBER AND DEPTH OF FILL (m) (PSI, 2023)
- BH154 BOREHOLE LOCATION, NUMBER AND DEPTH OF FILL (m) (JKE, DSI)
- TP101 TEST PIT LOCATION, NUMBER AND DEPTH OF FILL (m) (JKE, DSI)
- APPROXIMATE OUTLINE OF PROPOSED BUILDING FOOTPRINT
- APPROXIMATE OUTLINE OF PROPOSED DRIVEWAYS AND CARPARKS
- APPROXIMATE REMEDIATION EXTENT

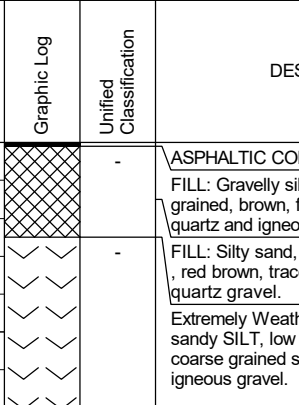
-	ASPHALTIC CONCRETE: 20mm.t FILL: Gravelly silty sand, fine to medium grained, brown, fine to coarse grained quartz and igneous gravel.	M			SCREEN: 1.88kg 0.02-0.3m, NO FCF POSSIBLY NATURAL

-	FILL: Silty sand, fine to coarse grained, red brown, trace of fine grained quartz gravel. Extremely Weathered andesite: gravelly sandy SILT, low plasticity, brown, fine to coarse grained sand, fine grained igneous gravel.	XW	(Hd)
					317	2			REFER TO CORED BOREHOLE LOG				MODERATE TO HIGH RESISTANCE
					316	3							
					315	4							
					314	5							
					313	6							
					312
